CASE STUDY

Collapse of Harbour Cay Condominium

Cocoa Beach, Florida

W. Gene Corley, SE, PE, PhD
Distinguished Member ASCE

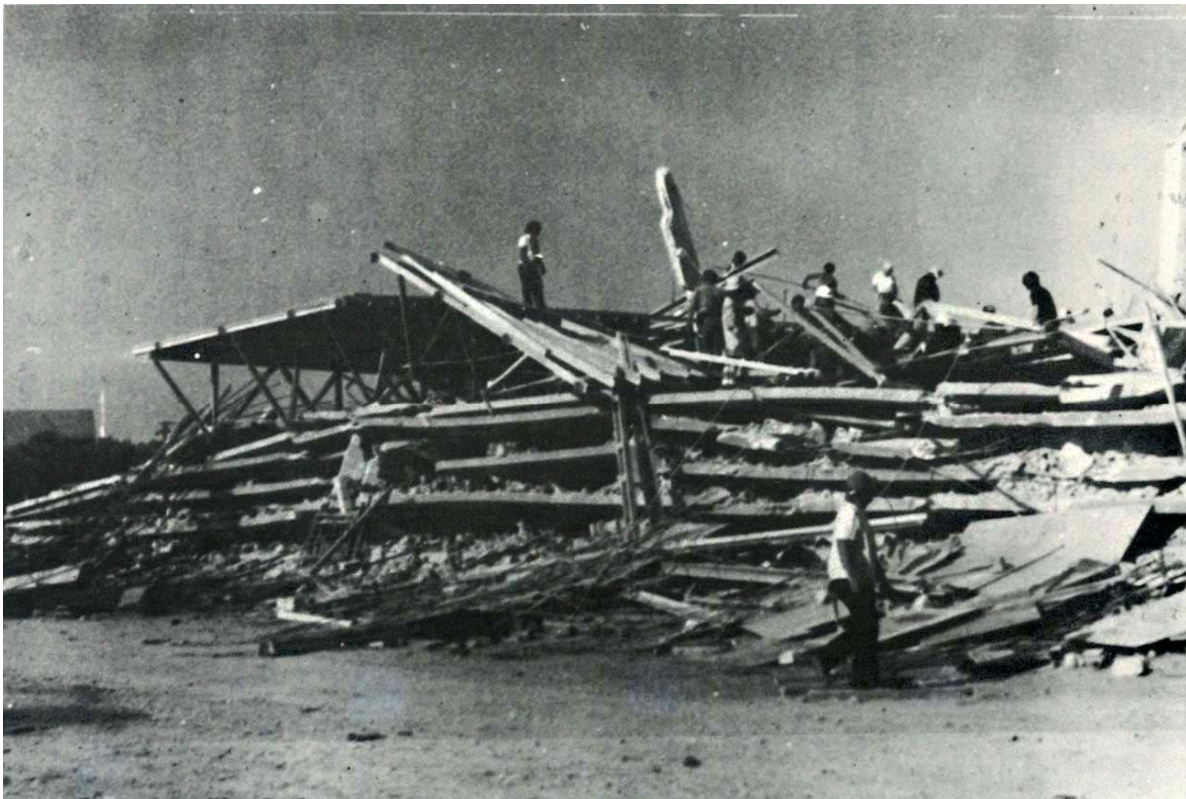
On March 27, 1981, Harbour Cay Condominium, a five-story flat-plate reinforced concrete building, collapsed as concrete was being placed for the roof slab. Eleven workers were killed and 23 others were injured. The photo below shows debris after collapse of the buildings.
