Structural Failures

A Case Study

Researched by Sam A. Rihani, PE, F.ASCE, SECB – September 2005

Hartford Coliseum

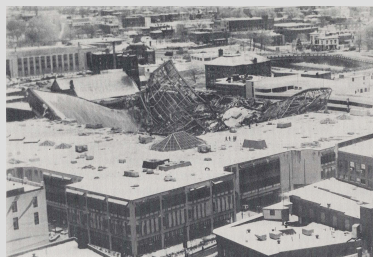
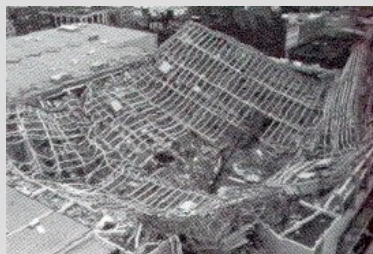
This roof was noted for being one of the first large-span roofs made possible by computer design and analysis, and was modeled as a space truss using a trusted program. The roof of this three-year-old structure collapsed at 4:15 AM on January 18, 1978 during a freezing rainstorm after a period of snow. Fortunately, there were no injuries sustained as a result of the collapse. The night before, there were over 5,000 people in the coliseum attending an event. Following several investigations of the collapse, it was determined that this was an instance primarily of inadequate structural design.
