Structure:	Large Retail Building
Location:	Yucca Valley, California
Completion Date:	About 1990
Date of Failure:	June 28, 1992
Failure Investigated By:	Gregg E. Brandow, PhD, SE Brandow & Johnston, Inc.
Causes of Failure:	Lack of Understanding of Seismic Performance and Design Requirements

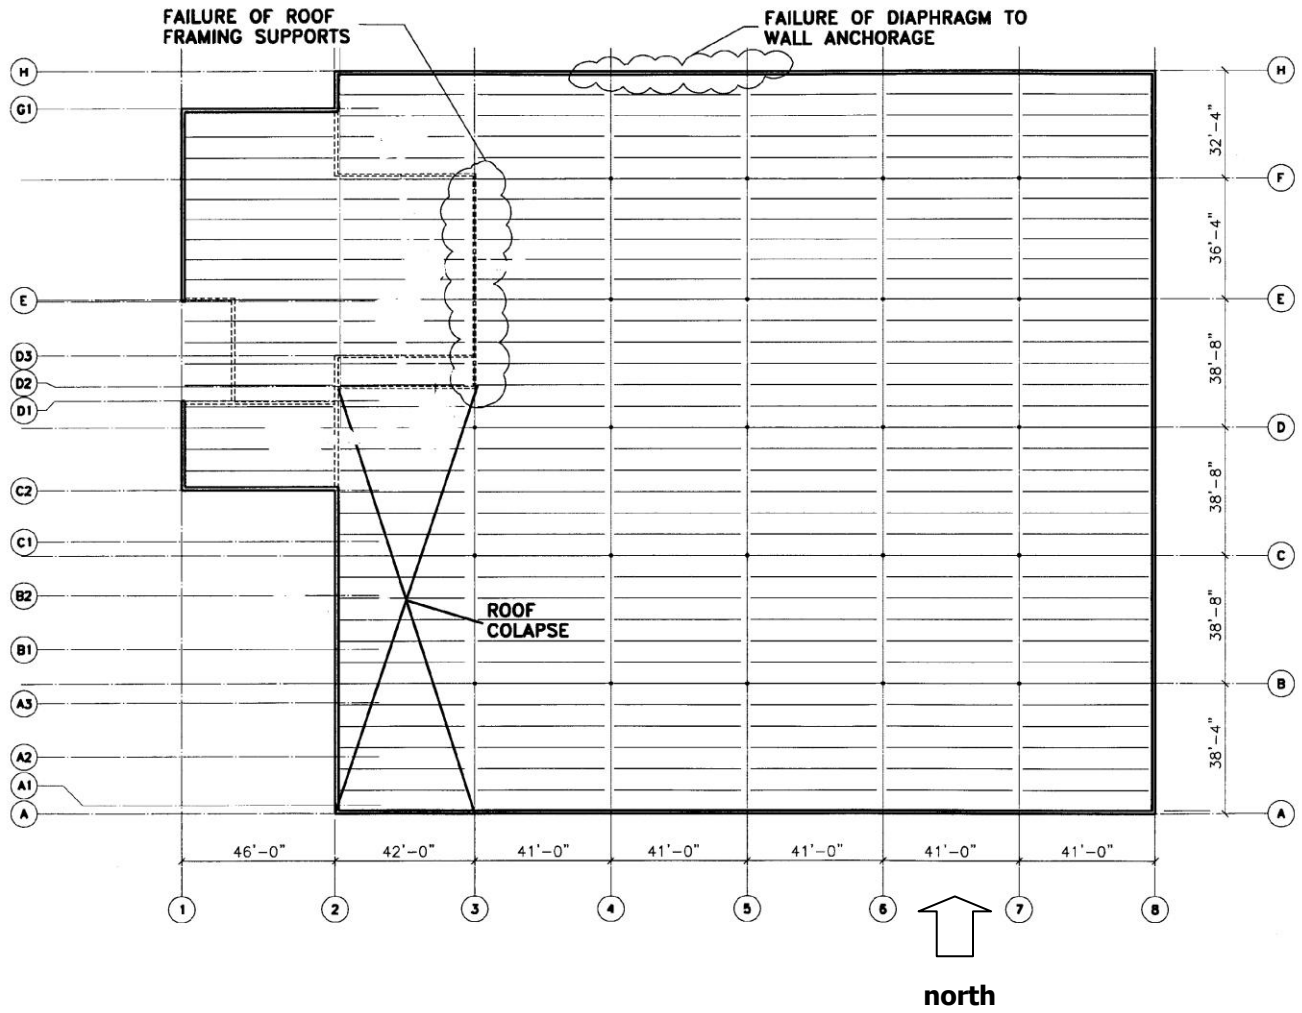
FIGURE 1

This large retail building is shown in the photograph and has overall dimensions of 293 feet by 223 feet, as shown in Figure 1. The building is single story except for a mezzanine that extends across the north bay of the building. The roof utilizes steel bar joists framing to steel truss girders with a typical bay size of 41 feet by 38 feet 8 inches. An inch and one-half thick metal deck spans between the joists and supports insulation and roofing. The roof framing is supported on steel pipe columns and on concrete masonry walls located on the perimeter of the building and on the interior in the building on grids 2 and 3 and grids D1, D2, D3, and F. The foundations are a bearing type foundation with isolated spread footings under the columns and continuous spread footings under the walls.

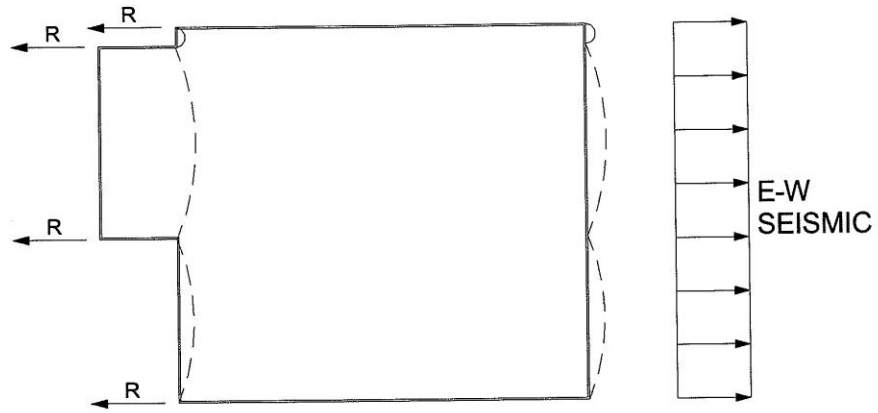
Figure 2: Before Wall Anchorage Failed

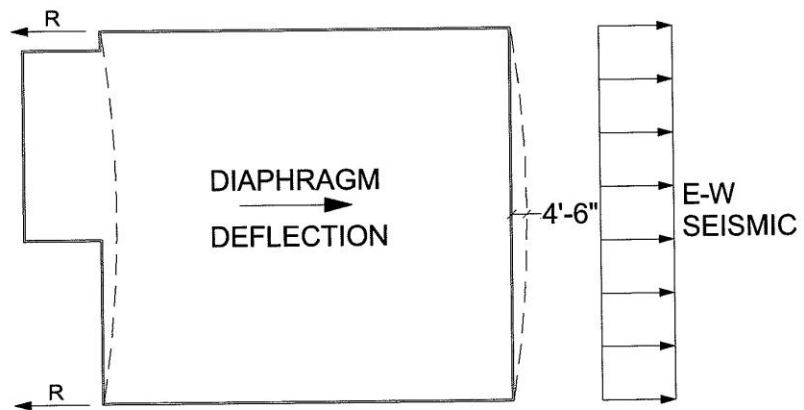
The failure of the diaphragm connection to the rear wall at grid H is a result of the very weak connection to the masonry wall. The anchor bolts failed by breaking out of the inside face of the wall.

Figure 3: After Wall Anchorage Failed

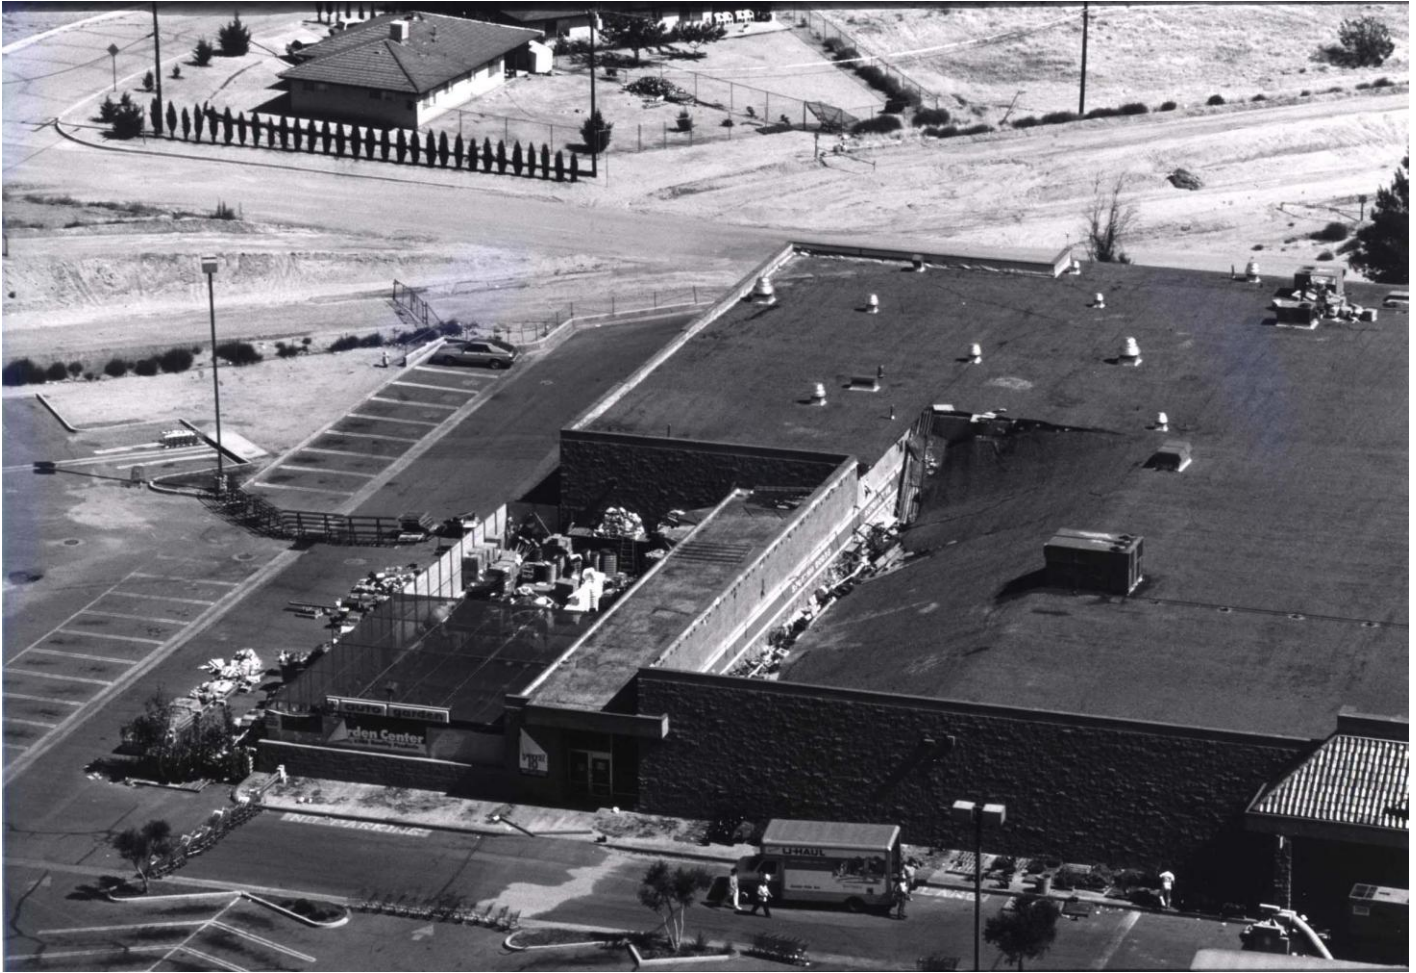
3. The diaphragm-wall connections are not detailed in a manner to assure an adequate transfer of forces between the wall and the trusses, as shown in Figure 4, truss girders or the bridging. Anchor bolts are so close to the face of the block that the connection capacity is very small compared to the capacity required by UBC Section 2310:
