Structural Failures: A Case Study
Researched by: Ronald O. Hamburger, SE

Structure Name: Royal Palm Hotel
Location: Tumon Beach, Guam

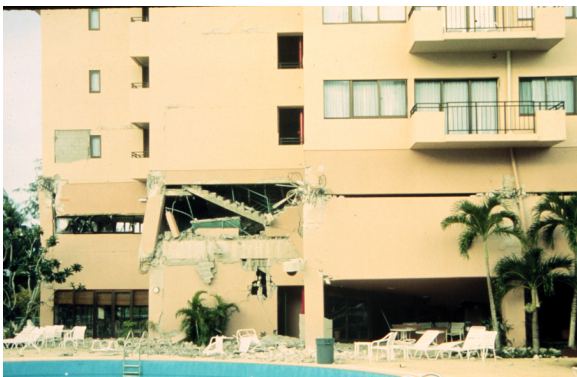
The Royal Palm Hotel consisted of twin 12-story reinforced concrete special moment resisting frames. The building was designed in 1990 in accordance with the requirements of the 1988 Uniform Building Code. Guam is subjected both to strong earthquakes and typhoons. The island was designated as Uniform Building Code Zone 3, and also had design wind speeds of 140 miles per hour.

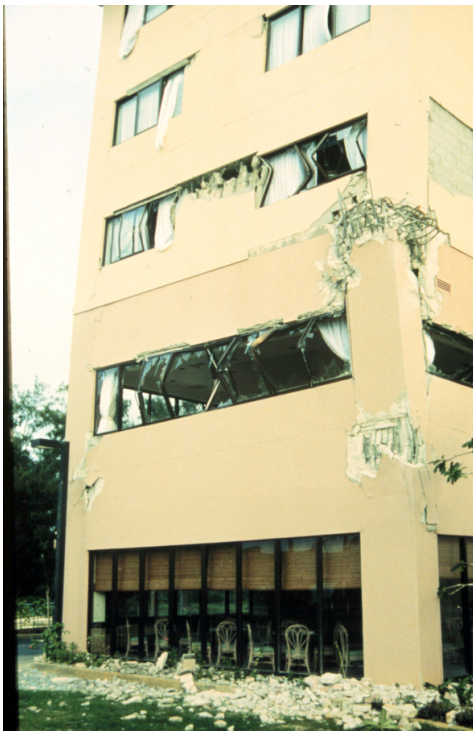
Two primary types of failure – shear failure of joints in the special concrete frame and shear failure and compressive crushing of gravity columns occurred at one of the two structure’s second story. This resulted in

partial collapse of the structure, and eventual demolition of both structures.
