Anatomy of a Collapse

Portions of the original design of the indoor practice facility, which collapsed in May 2009, injuring a dozen people, did not meet accepted codes and standards.

In May 2009, a practice facility used by the Dallas Cowboys collapsed during a storm that had wind speeds less severe than the nominal wind speed for which the structure was designed. An investigation of the collapse detailed several design errors that probably led to the failure of the large, fabric-covered steel structure.

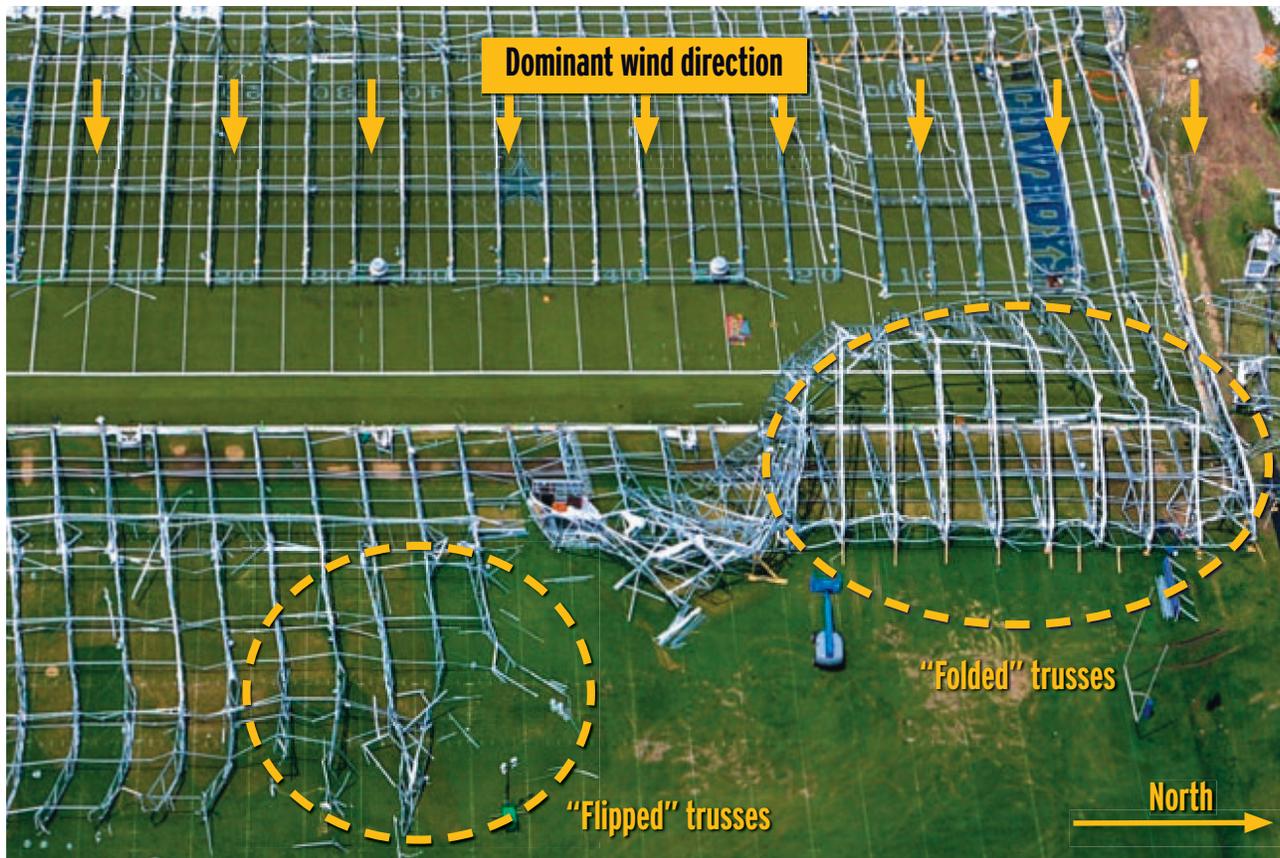
FIGURE 1
AERIAL VIEW OF
NORTH END OF
DALLAS COWBOYS
PRACTICE FACILITY

Figure 1 is an aerial photograph of the north end of the facility after the fabric coverings had been removed. The dominant wind direction on the day of the collapse was from the west,

and the overall east–west collapse pattern strongly suggests that collapse was initiated by failure of the east–west lateral resisting system—that is, the main truss elements. Further examination of the photograph shows two distinct patterns of failure: trusses that have been broken at the ridge and “flipped” outside the plan of the structure and trusses that have been pushed over but have folded into the plan of the structure.

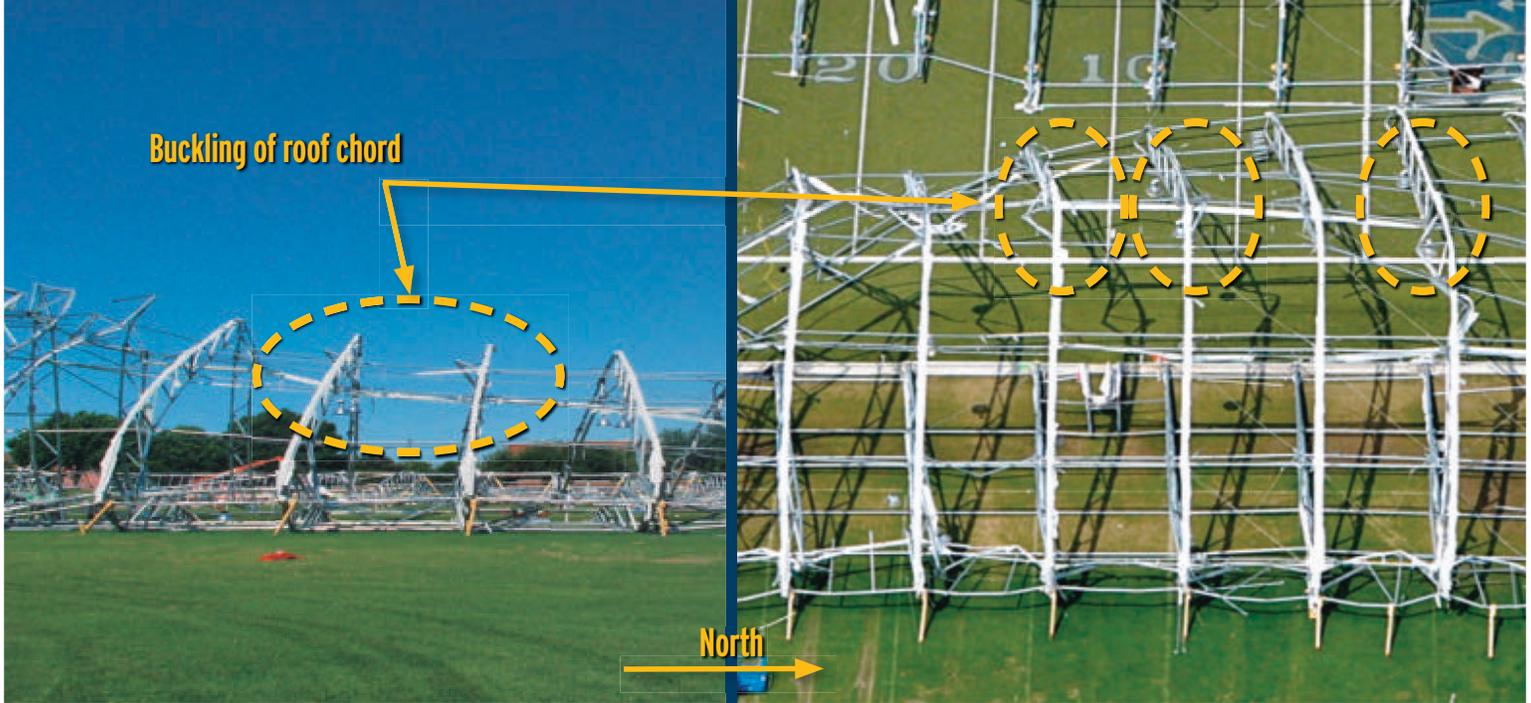
FIGURE 2
BUCKLED ROOF
CHORDS AT NORTH
END OF DALLAS
COWBOYS PRACTICE
FACILITY

closer examination of the folded trusses. As shown in figure 2, a buckled inner roof chord is clearly visible in at least two of the trusses. This type of failure is consistent with initiation of failure at the folded trusses.

Buckling of this chord as the initiating event is consistent with the overall collapse sequence as well as with the suddenness of the failure, which was evidenced by the video. As discussed below, an evaluation of the structure's design supports the theory that this failure was a likely initiating cause.

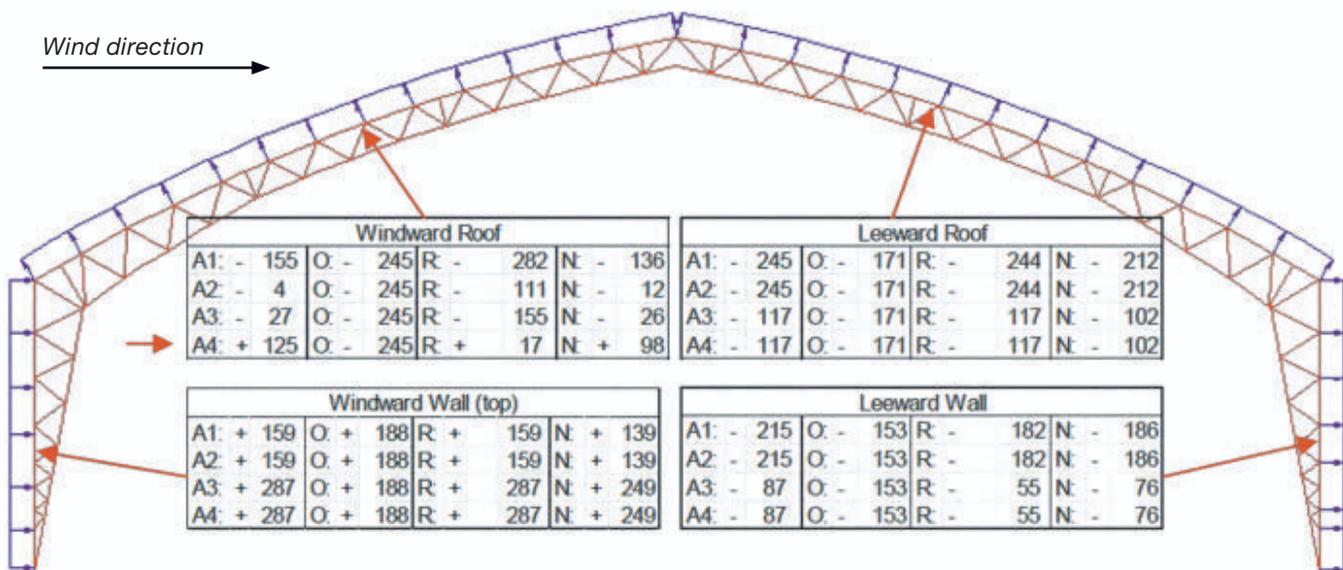
FIGURE 3
MAIN WIND-
FORCE-
RESISTING
SYSTEM
DESIGN
PRESSURES

structural analysis to produce the greatest member overloads. The wind pressures used for evaluating the structure in the direction perpendicular to the ridge are shown in figure 3.

The combination highlighted by the short arrow to the left in figure 3 is particularly significant because of the relatively high positive pressure required by ASCE 7, in contrast to the high negative pressure of the original design and the low positive pressure used by the retrofit design. Application of positive pressure to the windward roof tends to develop high compressive axial forces in the leeward inner chord member near the midpoint between

the ridge and the knee. By contrast, this section is not highly stressed under negative pressure, as envisioned in the original design. High compressive forces in this particular segment of the truss are consistent with the postulated failure sequence, as discussed below.

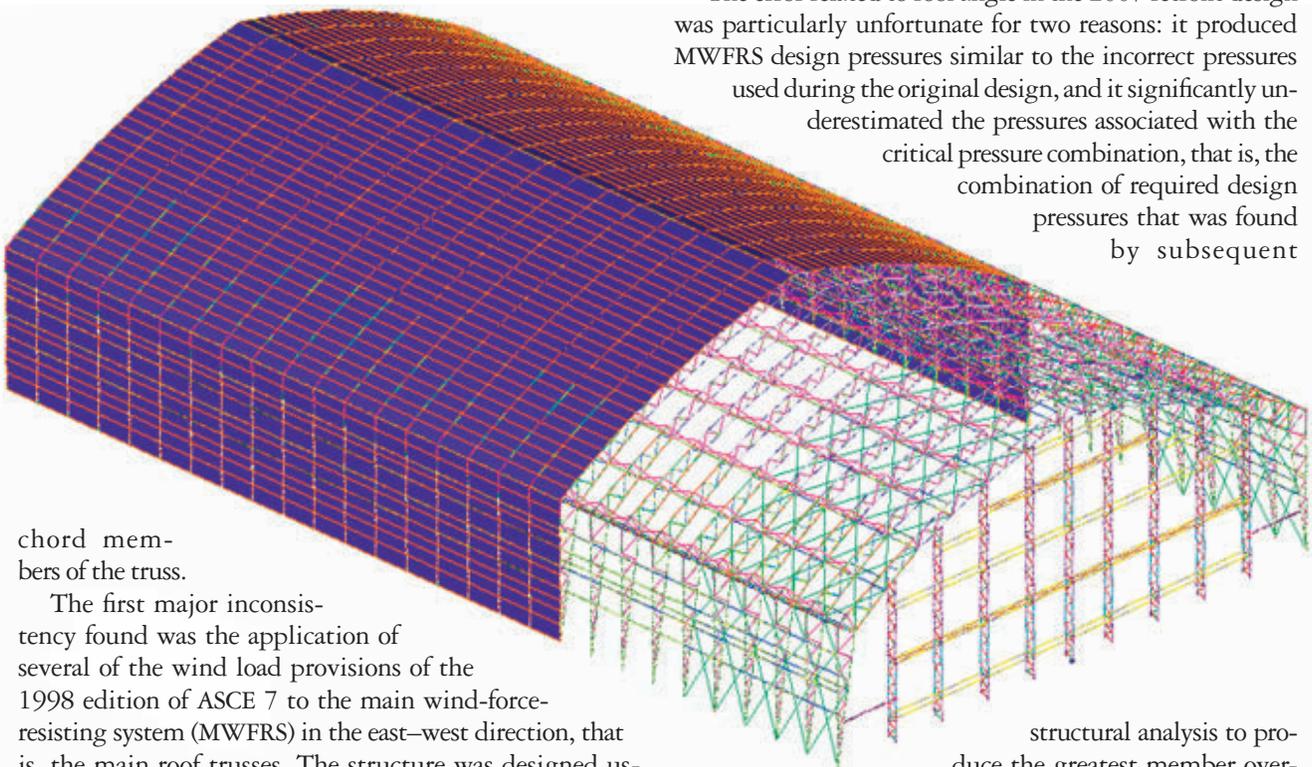
FIGURE 4
THREE-DIMENSIONAL
MODEL OF DALLAS
COWBOYS PRACTICE
FACILITY

Member demands were calculated using the wind pressures described previously by means of a two-dimensional model of a single truss and a 3-D finite-element model of the full structure, the latter shown in figure 4. The 3-D model included a representation of the outer fabric, which was idealized as a linear elastic membrane.

Under the assumption that the fabric provides no lateral bracing, the highest unfactored demand/capacity ratios at the nominal design wind velocity of 90 mph were found to be 2.99 at the inner chord at the truss knee, 2.77 at the outer chord of the windward roof, and 2.74 at the inner chord of the leeward roof. Given the similarity of these ratios, any of these locations could be regarded as possible initial failure sites. However, a geometrically nonlinear analysis of the 3-D structure indicates that the onset of buckling began at the inner chord of the leeward roof.
