Anatomy of a Collapse

Portions of the original design of the indoor practice facility, which collapsed in May 2009, injuring a dozen people, did not meet accepted codes and standards.

In May 2009, a practice facility used by the Dallas Cowboys collapsed during a storm that had wind speeds less severe than the nominal wind speed for which the structure was designed. An investigation of the collapse detailed several design errors that probably led to the failure of the large, fabric-covered steel structure.

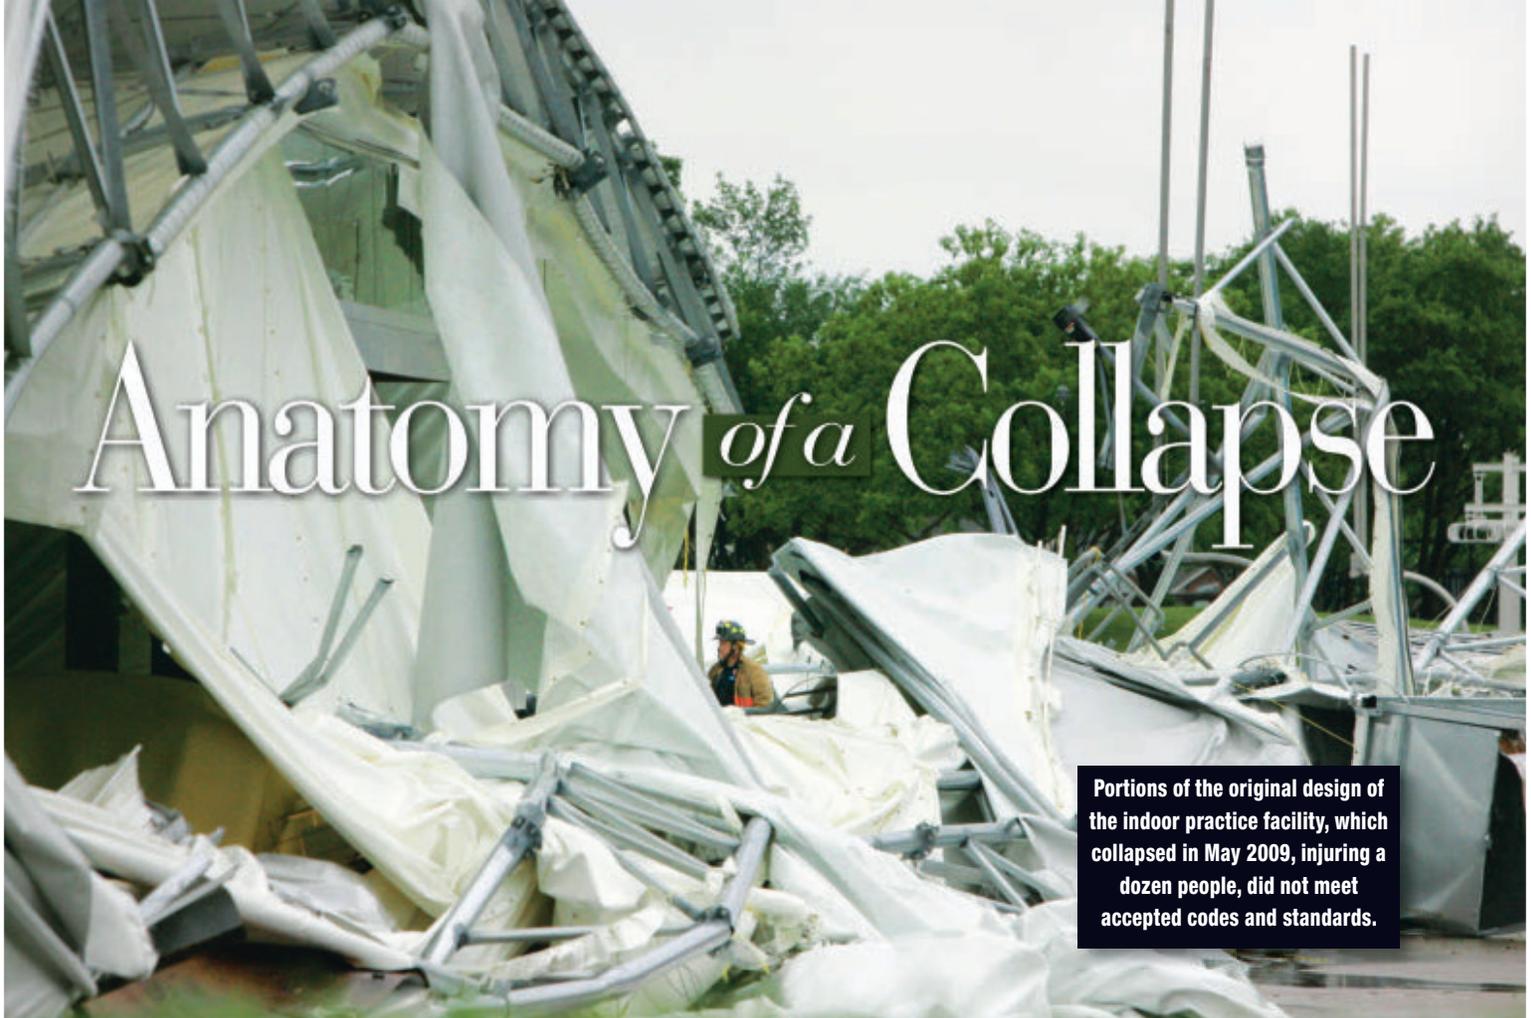
and the overall east–west collapse pattern strongly suggests that collapse was initiated by failure of the east–west lateral resisting system—that is, the main truss elements. Further examination of the photograph shows two distinct patterns of failure: trusses that have been broken at the ridge and “flipped” outside the plan of the structure and trusses that have been pushed over but have folded into the plan of the structure.

adjacent trusses and sequentially flip them outside the structure. The second possible sequence is that wind caused the failure of one of the folded trusses near the north end of the structure and that this failure progressively overloaded adjacent trusses, causing them to fold inward. Eventually, a large enough hole was opened in the structure for the wind to catch the inside surface of the structure and flip the remaining trusses outside.

The second possible sequence was deemed more likely. This conclusion was based on the notion that, if failure had started at the ridge and the wind had flipped trusses outside the structure, it would have been unlikely for this sequence to stop abruptly near the north end. Meanwhile, no strong driving force would exist to fold the remaining trusses in on themselves.
